# MEMORANDUM

**PROPOSAL:** Drainage easement and temporary use permit on City property for site drainage and foundation improvements for historic St. Nicholas Russian Orthodox Church.

**ST. NICHOLAS ORTHODOX CHURCH  
JUNEAU, ALASKA  
SITE GRADING ANALYSIS**

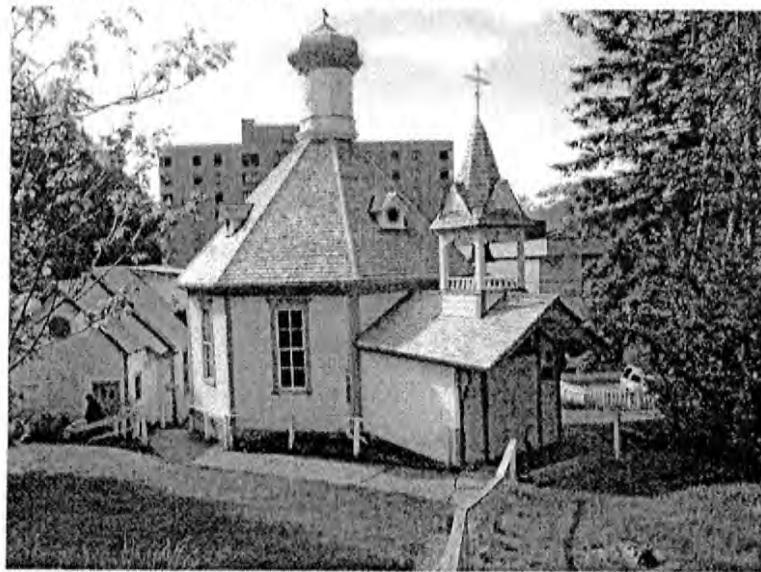
The rectory building has a steeply pitched sheet metal roof. Most of the roof runoff falls directly to the ground. On the east side of the structure, however, there is a short run of gutter along the eave with one downspout emptying out onto the sidewalk on 5<sup>th</sup> Street. It is assumed that snow falling from this steeply pitched roof also accumulates very near the existing building wood siding. Rot was observed on the wood siding of the building where no gutters were present. The church has cedar shingle roofing and is also steeply pitched. A gutter and downspout system captures runoff on the octagonal part of the structure, while the entry and bell tower sheet off water onto the ground. Of the downspouts, two empty onto the ground surface and two others appear to connect to underground piping. It could not be determined if this piping connects to the storm drain network on 5<sup>th</sup> Street or not.

St. Nicholas Orthodox Church – View looking South toward 5<sup>th</sup> Street

It is recommended that roof runoff be directly routed to the underground storm drain system wherever possible. 5<sup>th</sup> Street has an underground storm drain system with four 6" PVC service stub-outs located on site along the north side of the sidewalk. Connection to this storm drain system would involve minor excavation to locate the existing 6" PVC stub-outs located at the property line. Water that sheets off of the roof tends to splash off the ground onto the siding and may cause further damage to the siding. Gutters should be installed on the rectory building and church entry with downspouts tying into underground drain pipes. Even if there is an underground drain it may not be feasible to connect with all downspouts directly. In this case, downspouts may outfall into shallow swales in the landscaping that direct water to an area drain structure. Several area drains may be needed across the lot. See appendix for examples of construction details.

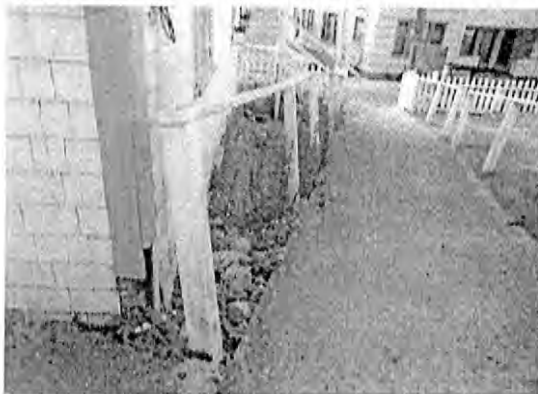
Wood siding and trim is rotten on lower wall of rectory building from standing water.

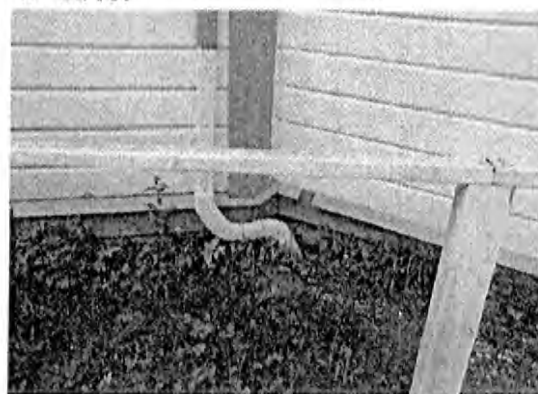
Church building has a nearly complete roof gutter system.

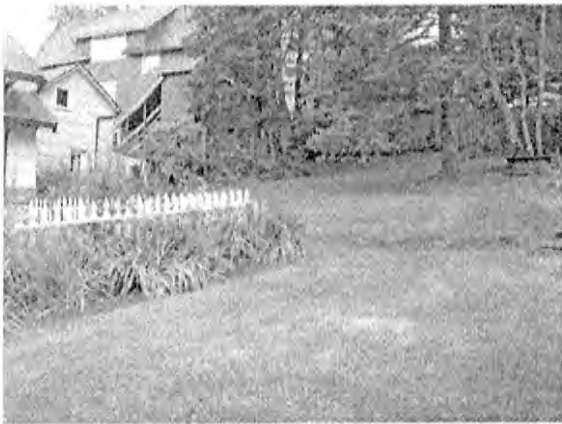
Landscaping berm along SW property line.

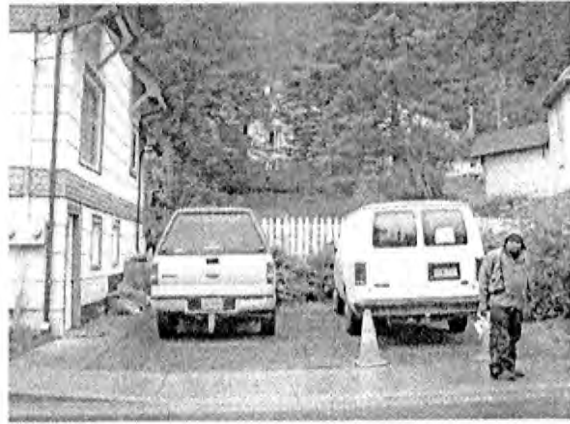
Gravel parking off 5<sup>th</sup> Street.

The gravel parking area can be paved to provide a more permanent path for surface water to flow towards 5<sup>th</sup> Street. This would eliminate any ponding behind the existing concrete sidewalk which could potentially lead to cracking in the concrete if left as is. If it is decided to maintain a gravel parking area, re-grading will eliminate the ponding. Note that the property line for Lot 1 passes through this area, so improvements in this area must be negotiated with the owner of the adjacent property.

- Pave existing gravel parking area on 5<sup>th</sup> Street to create permanent slope for directing runoff.
- Remove both lowered entryways to the rectory and replace them with new concrete landings, stairs and retaining walls. Install wall drain systems around the foundation wall in these areas to collect groundwater. We understand future rehabilitation plans include relocating the basement entry to the rectory's east elevation. If this does not occur, we recommend adding a concrete landing drain at the current entry location.

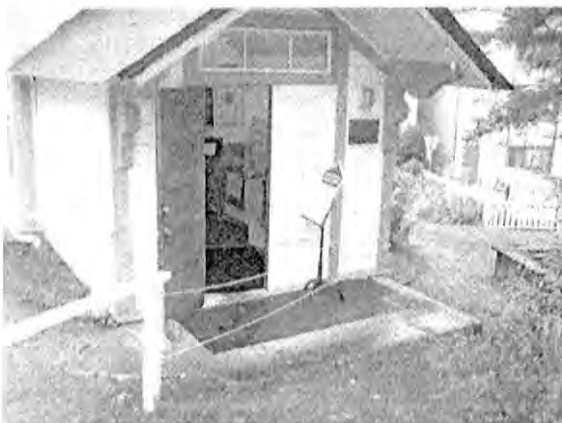
Cracking in concrete entry to church.

The concrete walkway leading up to the church from 5<sup>th</sup> Street is heavily travelled by pedestrians. To eliminate a potential trip hazard, the two areas of cracking in the sidewalk should be repaired.

- At a minimum remove and replace areas of the concrete pathway that display cracking or separation. It should be considered to replace the entire path to eliminate the uneven steps which are a tripping hazard. Options for hardscape replacement include ready-mixed concrete, asphalt pavement or unit pavers. Ready-mixed concrete appears to be the most feasible solution. To achieve a more historic appearance the concrete may be stamped to resemble a timber boardwalk.

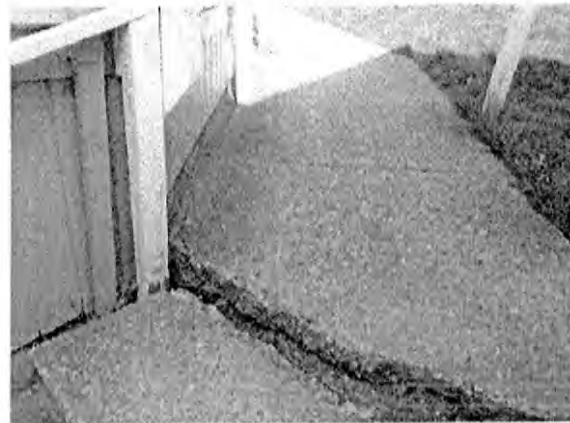
Separation of concrete walkway between structures is a potential tripping hazard.

The swales to the north of the church should be extended to new area drain structures near the concrete walkway. These area drains will collect surface water that would otherwise flow out onto the walkway and potentially cause more damage to the concrete. It is recommended to use CPP (Corrugated Polyethylene Pipe) Inlets which are a smaller and cheaper alternative to concrete area drains in places that do not receive heavy traffic. The area drains will need to be connected to the existing underground storm drain system on 5<sup>th</sup> Street. To make this connection, a portion of the concrete walkway will need removed and replaced. The area of separated concrete will be replaced as part of this work.

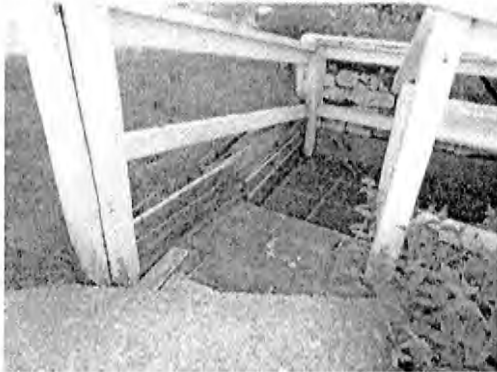
The rectory building is a wood-framed building bearing on a concrete foundation. A concrete stem wall encompasses the perimeter of the basement. The footings appear to be in good condition. Two areas of concern are the lowered entries on the north and southwest sides of the building. The entry stairs do not meet code requirements and are potential water traps.

North entry to the rectory basement.

It is suggested that the basement entry and the north entry to the rectory be reconstructed. This would involve concrete landing pads, concrete stairs and concrete retaining walls. The concrete landing pads will include a drain to route water into area drain structures. A foundation wall drainage system should also be considered to direct groundwater away from the building footings. The current plan to raise the building will help by making the north doorway landing closer to the existing grade of the lawn.

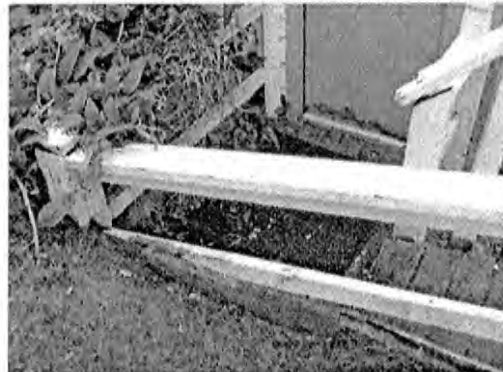
Wood decking is in poor condition.

In addition, it is recommended that the wood fence and railing structures be replaced throughout the site using pressure-treated or rot-resistant wood set on concrete bases.

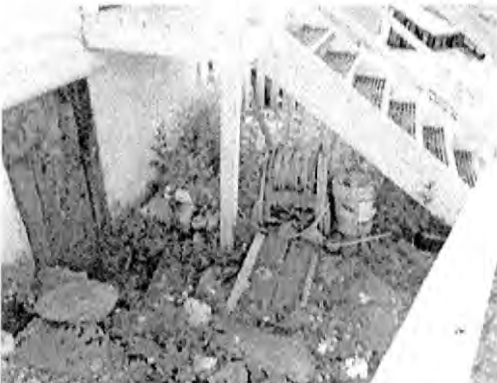
West entry to the rectory basement.

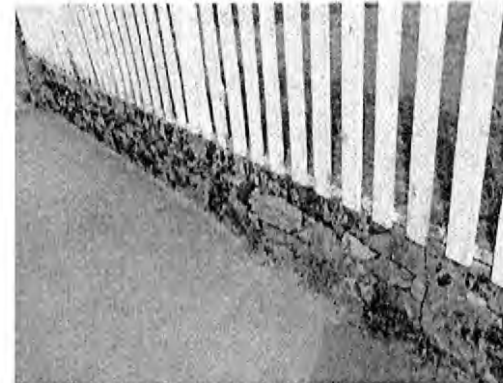
A short rock retaining wall follows behind the sidewalk on 5<sup>th</sup> Street. Loose rocks and cracked grout was observed in the wall. We assume that the wall obstructs ground water flow from the hillside. One wall drain was identified, but is in poor condition. Also, the wood fence and railing structures have moisture damage where they are in contact with the ground surface.

The rock retaining wall along 5<sup>th</sup> Street is deteriorating.

- Reconstruct rock retaining wall along 5<sup>th</sup> Street with weep holes for groundwater discharge.
- Reconstruct wood handrails for pedestrian traffic along the concrete walkway and fences showing signs of water damage.

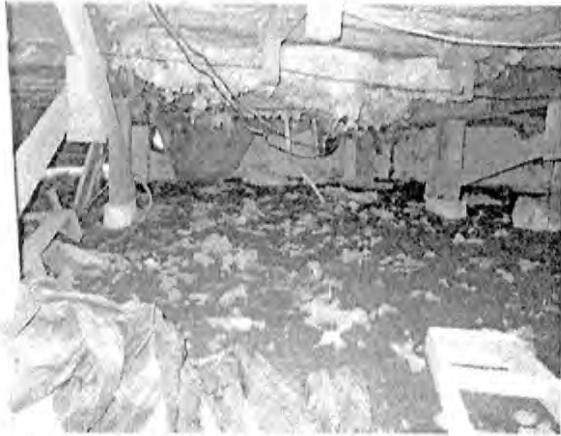
Timber-framing bears on a concrete wall and concrete piers beneath the church. The vapor barrier is incomplete.

Excessive moisture was found beneath the timber-framed church. Although no major structural problems were found, the rotting in the floor may warrant a more thorough investigation. Removing and replacing damaged wood members will add to the longevity of the structure. It is suggested that a complete vapor barrier be installed beneath the floor to prevent the humid air in the basement from infiltrating into the floor cavity. Adding additional vents may also help circulate air in the basement. Connecting the downspouts to underground pipes and area drains for catching surface water will help reduce the amount of water entering the basement. The concrete pier that has been displaced should be repositioned beneath the timber column and grout should be used to fill the void beneath the foundation wall that is being washed out.

- Add vapor barrier beneath church floor, additional vents in basement, reposition displaced concrete pier and grout void under washed-out foundation wall.

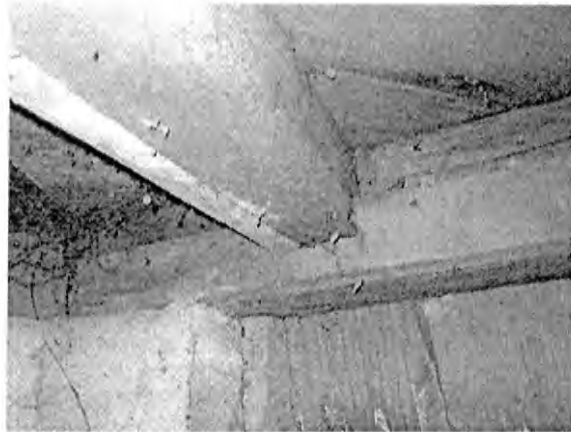
A 2x6 joist has been scabbed onto a 4x6 timber joist to reinforce the rotten ledger connection. (Church Building)

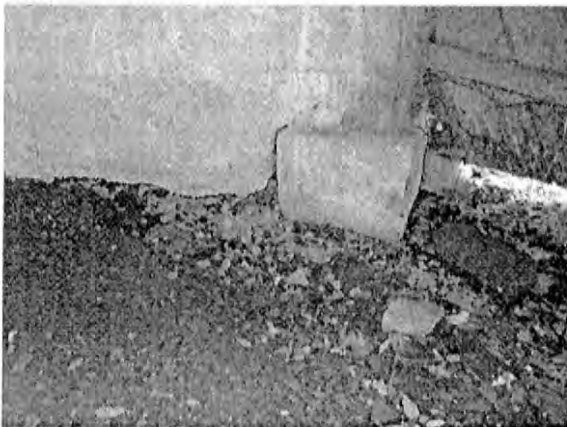
The foundation wall is being undermined near the concrete walkway. Note the downspout to the right. (Church building)

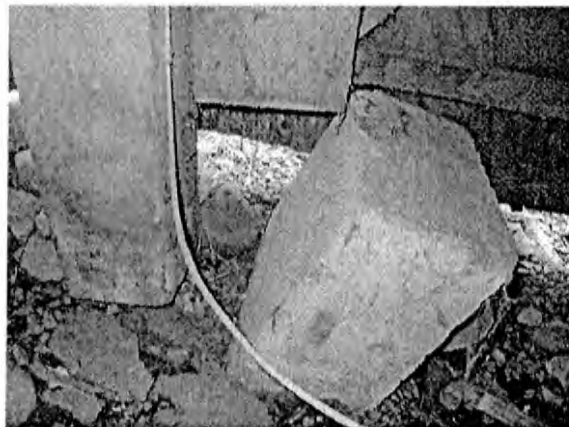
Downslope of the washed-out footing, a concrete pier has heaved out from under the 8x8 timber post. (Church Building)

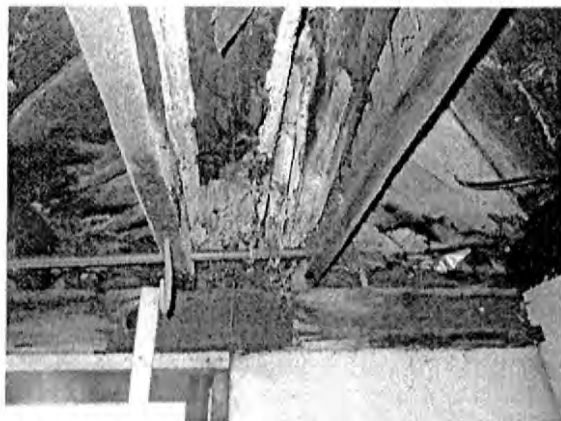
A severely rotted timber floor beam has been reinforced with two 2x6 joists in the basement of the rectory.

Rotting of the timber floor in the rectory is a concern to the structural integrity of the building and should be addressed. As evidenced by the water damage, it appears that the issue has been occurring for a long time. Although some additional framing has been added to bolster the weakened timbers, more permanent repairs are recommended. A more thorough investigation is necessary to determine the full extent of the damage and to provide detailed plans for reconstruction. Fortunately, changes can be made on the exterior of the building to prevent water from entering in the future. The first line of action should be to install gutters and downspouts to keep rain water from splashing on the siding. The lower portion of siding and trim will need replaced and a vapor barrier added on the wall at this time. Also, the steeply pitched roof sheds snow to the building perimeter that can act as a dam, causing water to back up against the building. A new wall drain system around the foundation wall will help drain groundwater away from the building. There is currently gravel on the west side of the building, but the rock stairs to the basement entry may act as a barrier to subsurface groundwater flow. Where space allows, gravel drains around the foundation wall should feed into perforated storm drain pipe and into the existing underground storm drain network. The lowered entries will need rebuilt to replace the rotted door jambs and to keep water from collecting there in the future. Also, the joists that have been compromised with excessive drilling for utility channels should be replaced.

- Replace rotten and damaged floor members in the rectory.

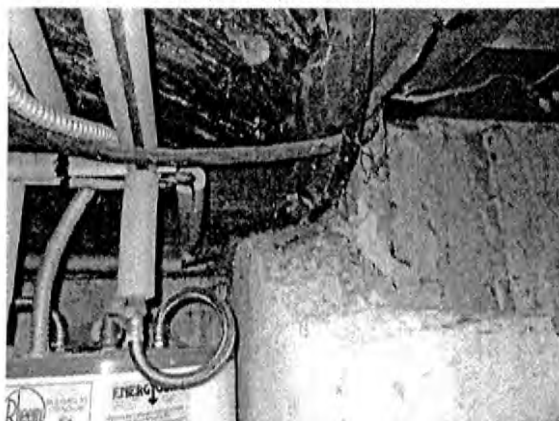
The wood floor above the water heater shows significant signs of water damage, which is reflective of the rotten siding on the exterior of this wall. (Rectory)

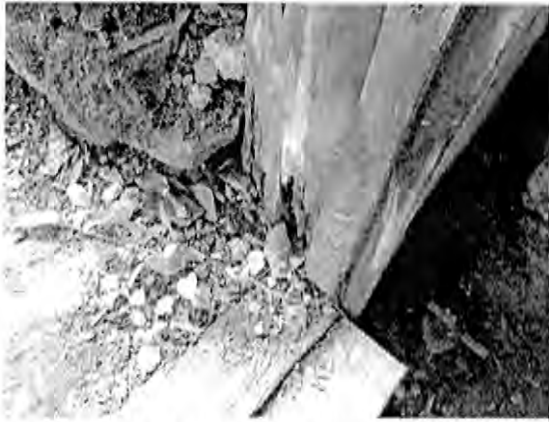
Rotten door jambs at the lowered entries in the rectory indicate poor drainage.

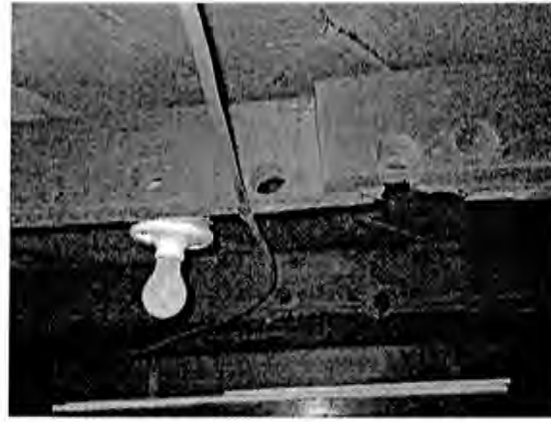
2x6 timber joists on the east side of the rectory have lost most of their strength due to excessive drilling.
